**NORTHERN CONCRETE PIPE**

## **Failed HDPE System Increases Cost of Simple Storm Sewer Improvements**

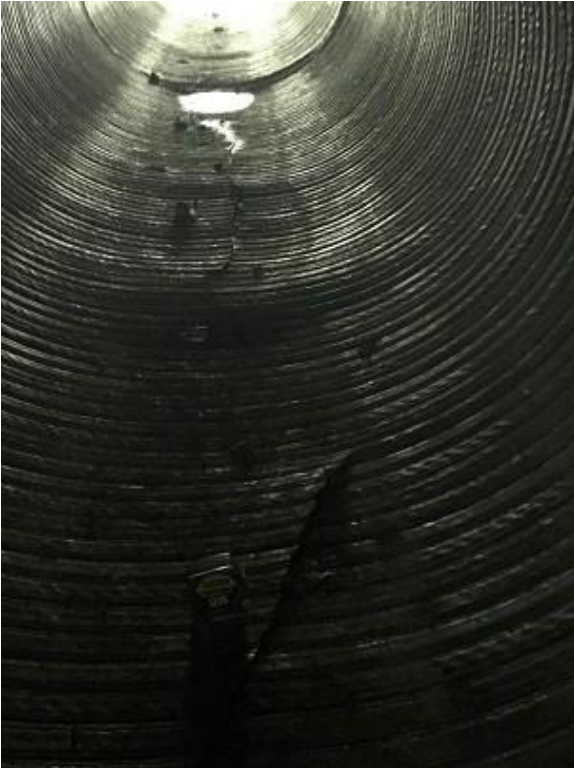
The westerly most HDPE culvert had deflected nearly 20%. It was considered a failed culvert that could not be used for the planned modification. After inspection of the entire HDPE flood control system it was determined that all seven culverts showed imminent failure characteristics. The village had no option other than to expand the project to include replacement of the flood control system.

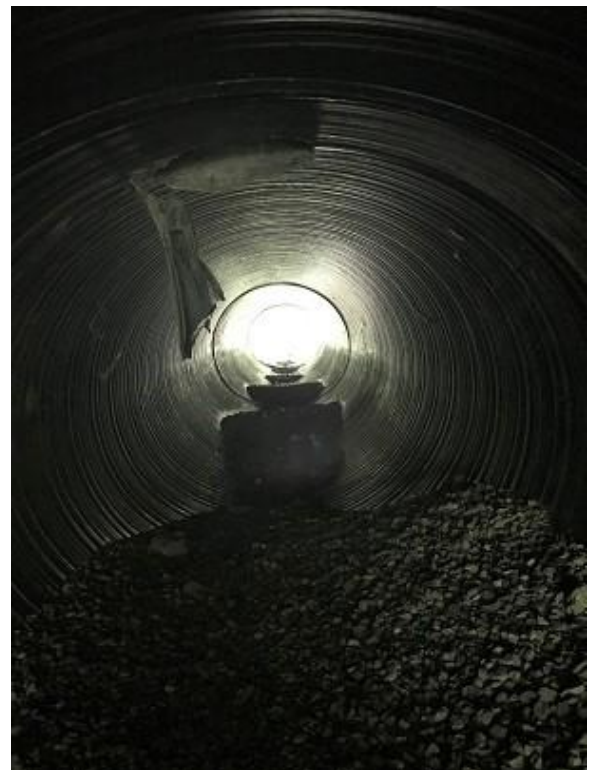
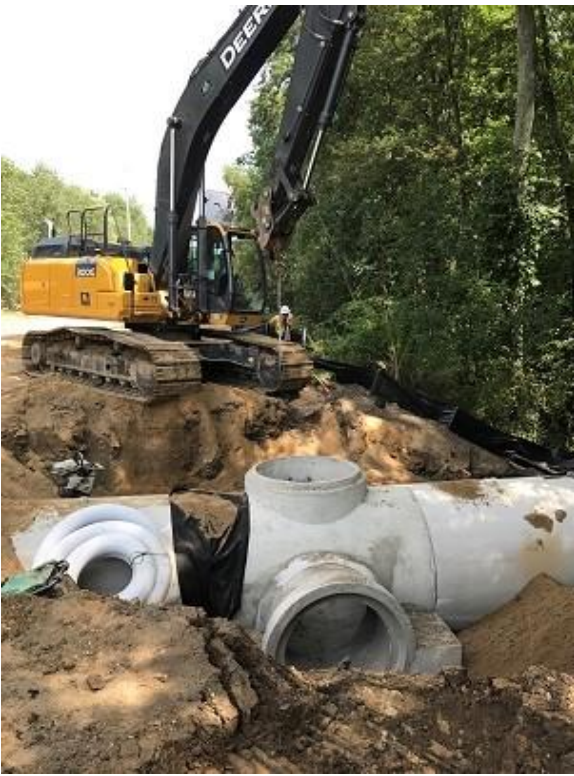
The manufacturer of the HDPE conduit suggested that the failed product be replaced with a contemporary type not available in 2001. The failed HDPE type had only been sold for 3 years.

Village management elected to specify RCP in lieu of HDPE in an expanded “remove and replace” project.

NCP provided an estimate to replace the seven 80-foot HDPE culverts with 60-inch diameter RCP. Despite competitive pricing from NCP, and the underground contractor, replacement of the culverts would cost the Village of Fowlerville nearly \$250,000. NCP teamed with Wolverine to save the village almost \$4,000 in value engineering. This was accomplished by precasting a 42-inch diameter horizontal Tee, in lieu of a 108-inch inside diameter manhole, and manufacturing a 48-inch diameter Manhole Tee into the same pipe. Thoughtful consideration of the problem coupled with the goal of installing a robust product that would be appropriate for the application kept the roadway from being closed indefinitely. The underground contractor, C & D Hughes, Inc., completed the culvert replacement in 2 weeks.
