**NORTHERN CONCRETE PIPE**

## **Failed HDPE System Increases Cost of Simple Storm Sewer Improvements**

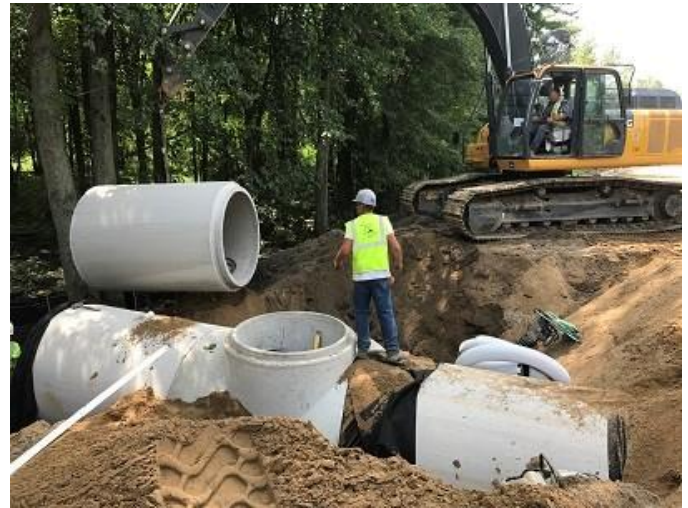
The westerly most HDPE culvert had deflected nearly 20%. It was considered a failed culvert that could not be used for the planned modification. After inspection of the entire HDPE flood control system it was determined that all seven culverts showed imminent failure characteristics. The village had no option other than to expand the project to include replacement of the flood control system.

The manufacturer of the HDPE conduit suggested that the failed product be replaced with a contemporary type not available in 2001. The failed HDPE type had only been sold for 3 years.

Village management elected to specify RCP in lieu of HDPE in an expanded “remove and replace” project.

NCP provided an estimate to replace the seven 80-foot HDPE culverts with 60-inch diameter RCP. Despite competitive pricing from NCP, and the underground contractor, replacement of the culverts would cost the Village of Fowlerville nearly \$250,000. NCP teamed with Wolverine to save the village almost \$4,000 in value engineering. This was accomplished by precasting a 42-inch diameter horizontal Tee, in lieu of a 108-inch inside diameter manhole, and manufacturing a 48-inch diameter Manhole Tee into the same pipe. Thoughtful consideration of the problem coupled with the goal of installing a robust product that would be appropriate for the application kept the roadway from being closed indefinitely. The underground contractor, C & D Hughes, Inc., completed the culvert replacement in 2 weeks.
